SACoMaTiS 2008

International RILEM Conference

on Site Assessment of  
Concrete, Masonry and Timber

## HALF-CELL POTENTIAL MEASUREMENTS TO ASSESS CORROSION RISK OF REINFORCEMENT STEELS IN A PC BRIDGE

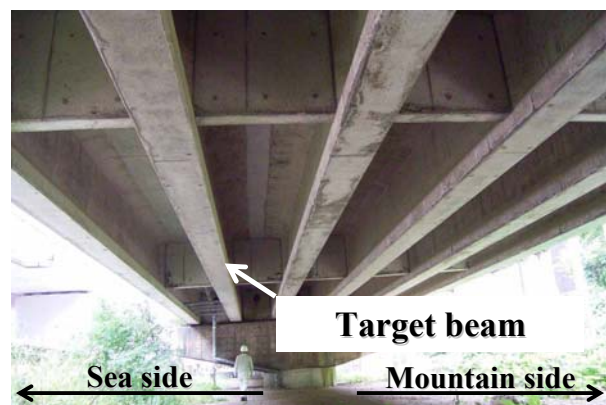
Figure 1: Appearance of PC bridge

Figure 1 shows the appearance of the PC bridge. It was built in 1975, and has a span length of 25 m. Much airborne salt must have been present during the in-service period because the bridge locates within 200 m from the coastline. The second beam from the sea side was selected for the experiment. It showed no signs of corrosion on the concrete surface and had never been repaired. However, corrosion was highly likely to have started behind the concrete cover since the PC bridge has been used in the severe chloride environment for over 35 years. A visual inspection cannot provide adequate information on the corrosion risk of steels embedded in concrete.

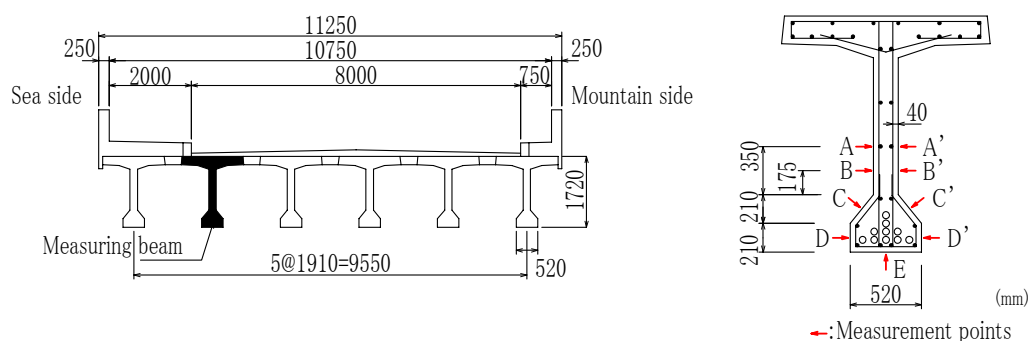
Figure 2: Measurement points of half-cell potential on the beam

The half-cell potential was measured as follows. First, the electrical continuity of web reinforcements was checked at three distant points: PC1, PC2 and PC3, which were selected at random on the web. The concrete cover was removed and web reinforcements were exposed. Then, the potential differences among the three points were measured with a voltmeter and all measured values were less than 1 mV. Thus, the electrical continuity was verified. Additionally, these windows were used for the connection between the web reinforcement and the high-impedance voltmeter. Second, tap water was sprayed on the concrete surface for the pre-wetting in order to reduce the fluctuation of the measured values. Third, the reference electrode and the web reinforcement were connected to a high-impedance voltmeter with lead wires. After the pre-wetting and the connection of devices, the reference electrode was placed on the concrete surface. The measured values of the half-cell potential were recorded at regular intervals. The measurement points were spaced 300 mm apart in the direction of the bridge axis, which corresponded with the spacing of the web reinforcement. Hence, the measurement points were located immediately above the web reinforcements. This was because the corrosion risk due to the airborne salt was likely to be higher for the web reinforcement located nearest to the concrete surface than other steels. Figure 2 shows the measurement points of the half-cell potential on the beam. Nine measurement points were arranged on each cross section: two on the web, four on the lower flange and one on the bottom. These measurement points were set on 74 cross sections on the beam. Figure 3 shows the configuration of half-cell potential measurements.

Additionally, reliable information is indispensable to assess the condition of concrete structures. In the current research, the measurement points were placed at 300 mm according to the spacing of the web reinforcement. If the measurement points had been spaced further than 300 mm apart, the half-cell potential at measurement points 74 and 75 may not have been obtained, in which case the negative potential area and the localized corrosion might have been overlooked. Hence, the measurement points should be placed according to the spacing of the steel.

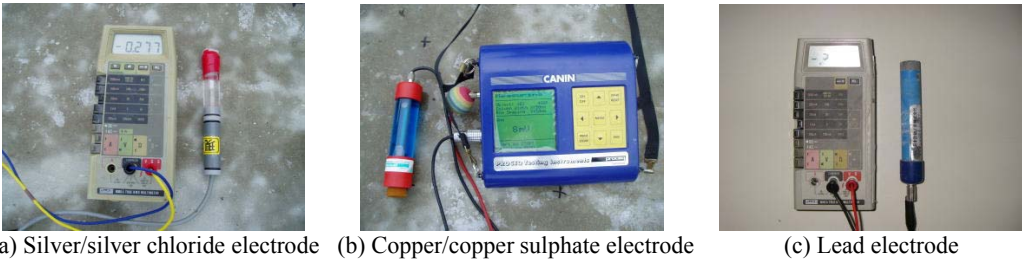
Figure 4: Reference electrodes

The experiment was conducted in order to clarify the fluctuation of the half-cell potential due to various factors: the temperature, the type of reference electrode, and the pre-wetting time. To do this, the half-cell potential was measured in summer and winter. The temperature was approximately 30°C in summer and 5°C in winter. Three types of reference electrode were used for the measurement: a silver/silver chloride electrode, a lead electrode and a copper/copper sulphate electrode. Figure 4 shows these reference electrodes. Each measured value was converted to the potential of the copper/copper sulphate electrode at 25°C using the equations shown in Table 1 [5]. Moreover, the pre-wetting time was extended from 30 minutes to 150 minutes by 60 minutes to increase the moisture content of the concrete.

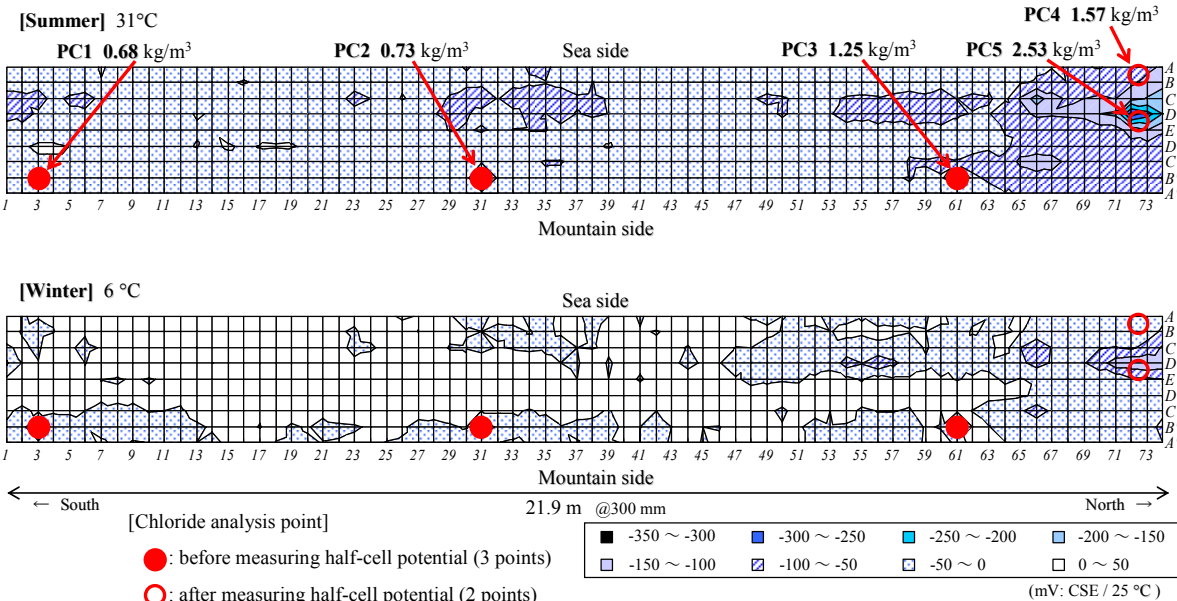
Figure 5: Equipotential contour maps of PC bridge in summer and winter

Figure 5 shows the results of half-cell potential measurements and the chloride analysis. The results of half-cell potential measurements are represented as an equipotential contour map for each season, using different colors for each 50 mV. The measurement was conducted with the silver/silver chloride electrode after 30 minutes of the pre-wetting. The depth of carbonation by spraying phenolphthalein solution was approximately 9 mm. The thickness of concrete cover at the web reinforcement was 40 mm. Thus, it is reasonable to assume that carbonation has no relationship with corrosion. The measured values of the moisture content on the concrete surface were between 5% and 8% after the pre-wetting. The compressive strength of concrete obtained by compression tests of the core sample taken for the chloride analysis was approximately 45 MPa.

The measured values of the half-cell potential in summer were more negative than those in winter. The most negative potential was obtained around the measurement points of 73 on the measurement line of D: -320 mV in summer and -145 mV in winter. This area was located on the sea side of the beam, where much airborne salt was present from the sea water. Comparing the results of the chloride analysis, the chloride content at PC5 was highest among the five points PC1 to PC5. Figure 6 shows the relationship between the half-cell potential and the chloride content at the web reinforcement. The half-cell potential shifted depending on the season, but it was obvious that the negative potential was measured where the chloride content at the web reinforcement was high.

As shown in Figure 5, there is a difference of the half-cell potential between summer and winter. Most of the measured values were between -50 mV and 0 mV in summer, and between 0 mV and 50 mV in winter. Figure 8 compares the half-cell potential in summer and winter, deriving the measured values on the measurement line of D from Figure 5. The half-cell potential in summer was shifted by approximately 40 mV to more negative values than in winter. This shift was induced throughout the beam, but the gradient of the half-cell potential remained at the same pattern. These facts imply that the half-cell potential fluctuated due to the change of corrosive environment in concrete depending on the temperature. The corrosive environment became more severe as the temperature increased. Meanwhile, the difference of

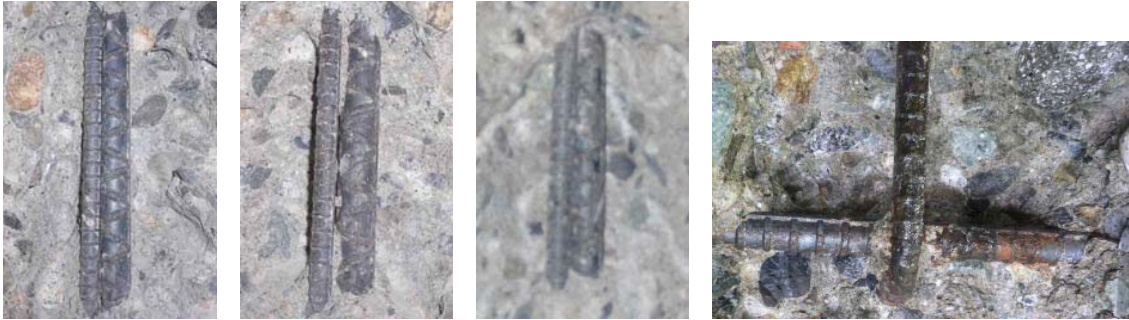
Figure 7: Corrosion state of web reinforcements

Figure 7 shows the corrosion state of web reinforcements at four points: PC1, PC2, PC3 and PC5. Corrosion was found only at PC5, where the most negative potential was measured. Hence, the negative potential area on the equipotential contour map should be a good indicator to detect points with high chloride content and localized corrosion even if there are no signs of corrosion on the concrete surface.

(a) PC1 (b) PC2 (c) PC3 (d) PC5  
 \* PC1, PC2, PC3: No corrosion, \*\* PC5: Corrosion

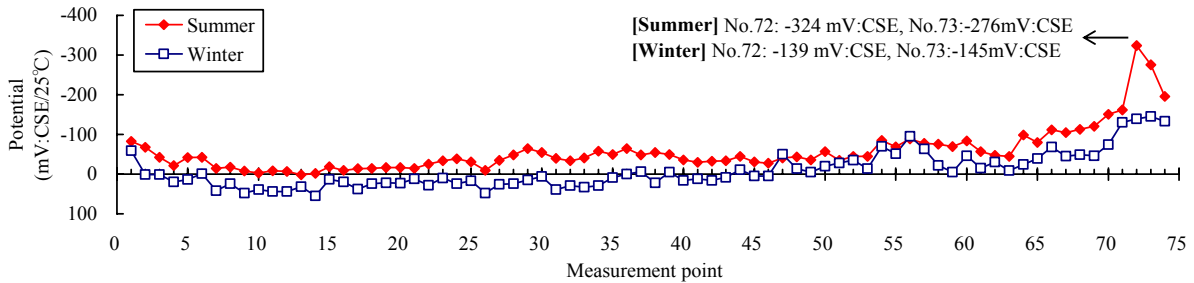
Figure 8: Half-cell potential in summer and winter

the gradient became clear in summer, which was helpful to detect the negative potential area on the equipotential contour map.

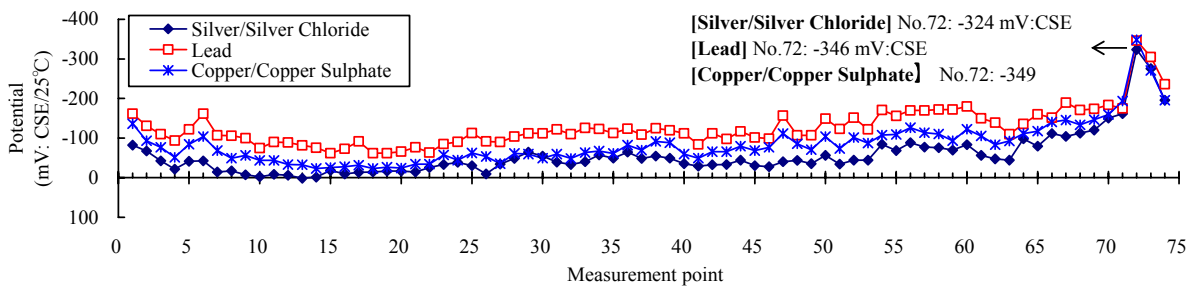
Figure 9: Half-cell potential with three types of reference electrode

Figure 9 shows the half-cell potential for three types of reference electrode: the silver/silver chloride electrode, the lead electrode and the copper/copper sulphate electrode. The measurement was conducted after 30 minutes of the pre-wetting on the measurement line of D in summer. The average difference of the measured values among the three reference electrodes was approximately 70 mV on the whole of the beam. The negative potential was obtained in the following order: the lead electrode, the copper/copper sulphate electrode and the silver/silver chloride electrode. However, the potential gradient with three different reference electrodes was almost equal. Additionally, the difference of the measured values decreased around the measurement points of 74 and 75, where the most negative potential was obtained. Thus, it is unlikely to lead to different interpretations depending on the type of reference electrode.

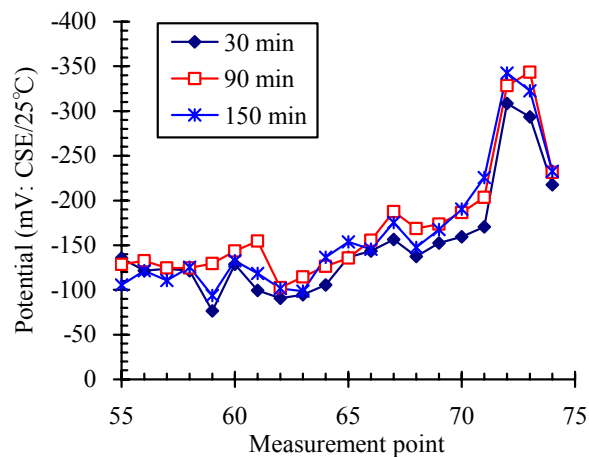
Figure 10: Half-cell potential for different pre-wetting times

Figure 10 shows the half-cell potential for different pre-wetting times. The pre-wetting time was 30, 90 and 150 minutes. The measurement was conducted on the measurement line of D with the copper/copper sulphate electrode in summer. The half-cell potential became more negative with increase of pre-wetting time. However, the potential gradient remained at the same pattern again; the most negative potential was obtained at the measurement points of 74 and 75. Hence, the length of the pre-wetting time also affected the measured values of the half-cell potential, but the potential gradient was not changed.
